# *Clem Labine's* TRADITIONAL BUILDING The Professional's Resource For Public Architecture

## A REBIRTH OF PUBLIC ART

**Francis Davis Millet's "Mail Delivery" murals of the Cleveland Federal Building were rescued by the U.S. GSA Fine Arts Program in a recent restoration by McKay Lodge Fine Arts Conservation Laboratory, Inc. of Oberlin, Ohio.**

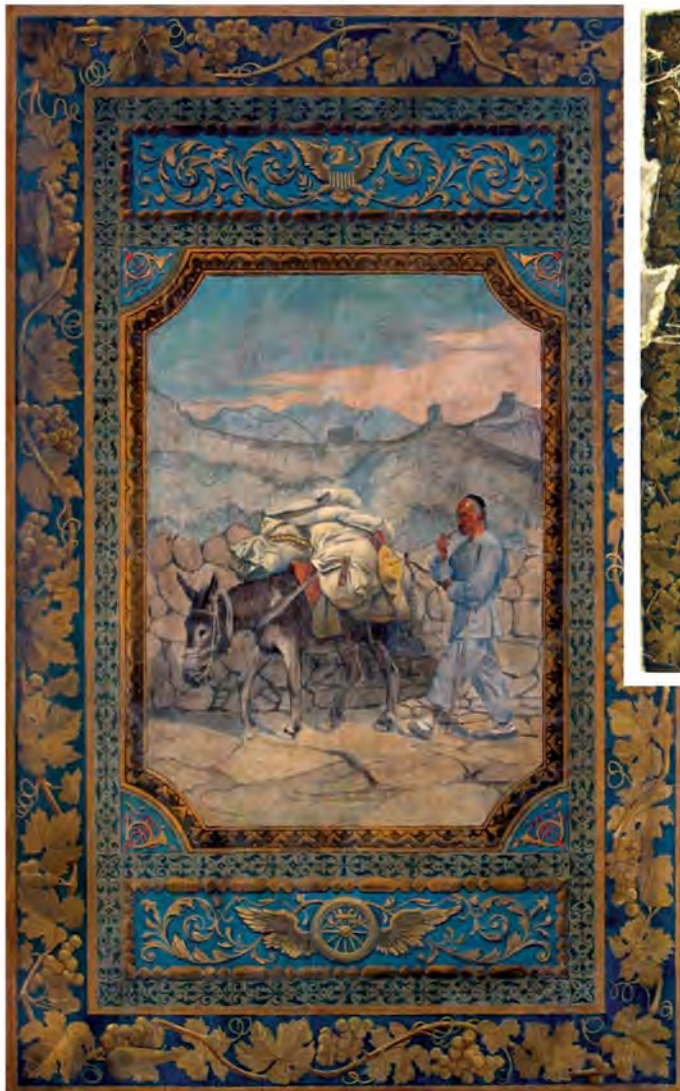
Above: After in-painting, Millet's "Mail Transfer, North China" mural looks very much as it did when it was first hung in 1911.

paint loss, due to the workers tugging at them when they were taken down. "They caused a shearing of the paint," Lodge explains, "and left what seemed like lightning bolts of white ground cutting through the murals. Easily 75% of the work we had to do on them was in-painting to replicate these missing sections." Hundreds of hours of work were required to properly in-paint the damaged murals.

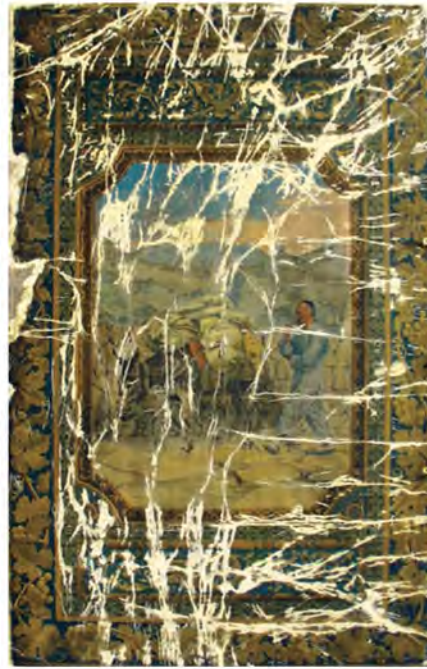
Inset: The paint losses have been filled in on this Chinese-themed mural, but the painstaking job of in-painting the missing areas has yet to begin.

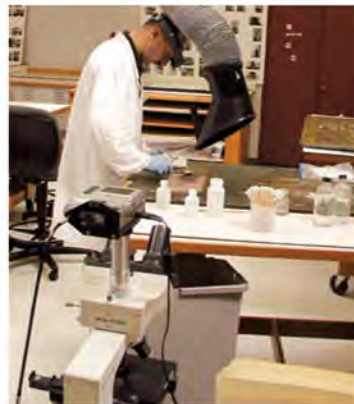
Lower right: Layers of linseed oil had been haphazardly applied to the murals throughout the years, presenting conservator Stefen Dedecek with the complex task of cleaning away the old oil films that had darkened the paintings.

The experts of McKay Lodge Conservation Laboratory, Inc. of Oberlin, OH, were brought in on the project to perform the painstaking restoration of the entire mural series. Robert Lodge comments, "These pictures have had a hard life. They had been coated with layers of linseed oil at varying times, which has caused the murals to darken. And because that work was done unevenly through the years, the murals are in varying states of clarity. In restoring them, we have to be careful to bring them to a uniform level, so that no one panel is brighter than the others. Fortunately, they'll be arranged with some space between them, which allows us some liberties in the range of the cleaning, as opposed to everything appearing exactly the same way."
